STUDY AREA 16
(Former Creosote Dip Tank And Fire Fighting Training Area)
Comprehensive Report/Study Area Screening Evaluation Volume
Volume 1: Technical Report And Appendices

Naval Construction Battalion Center
Davisville, Rhode Island

Contract No. N62472-92-D-1296
Contract Task Order No. 60

FINAL
December 1999
29600.60.2293

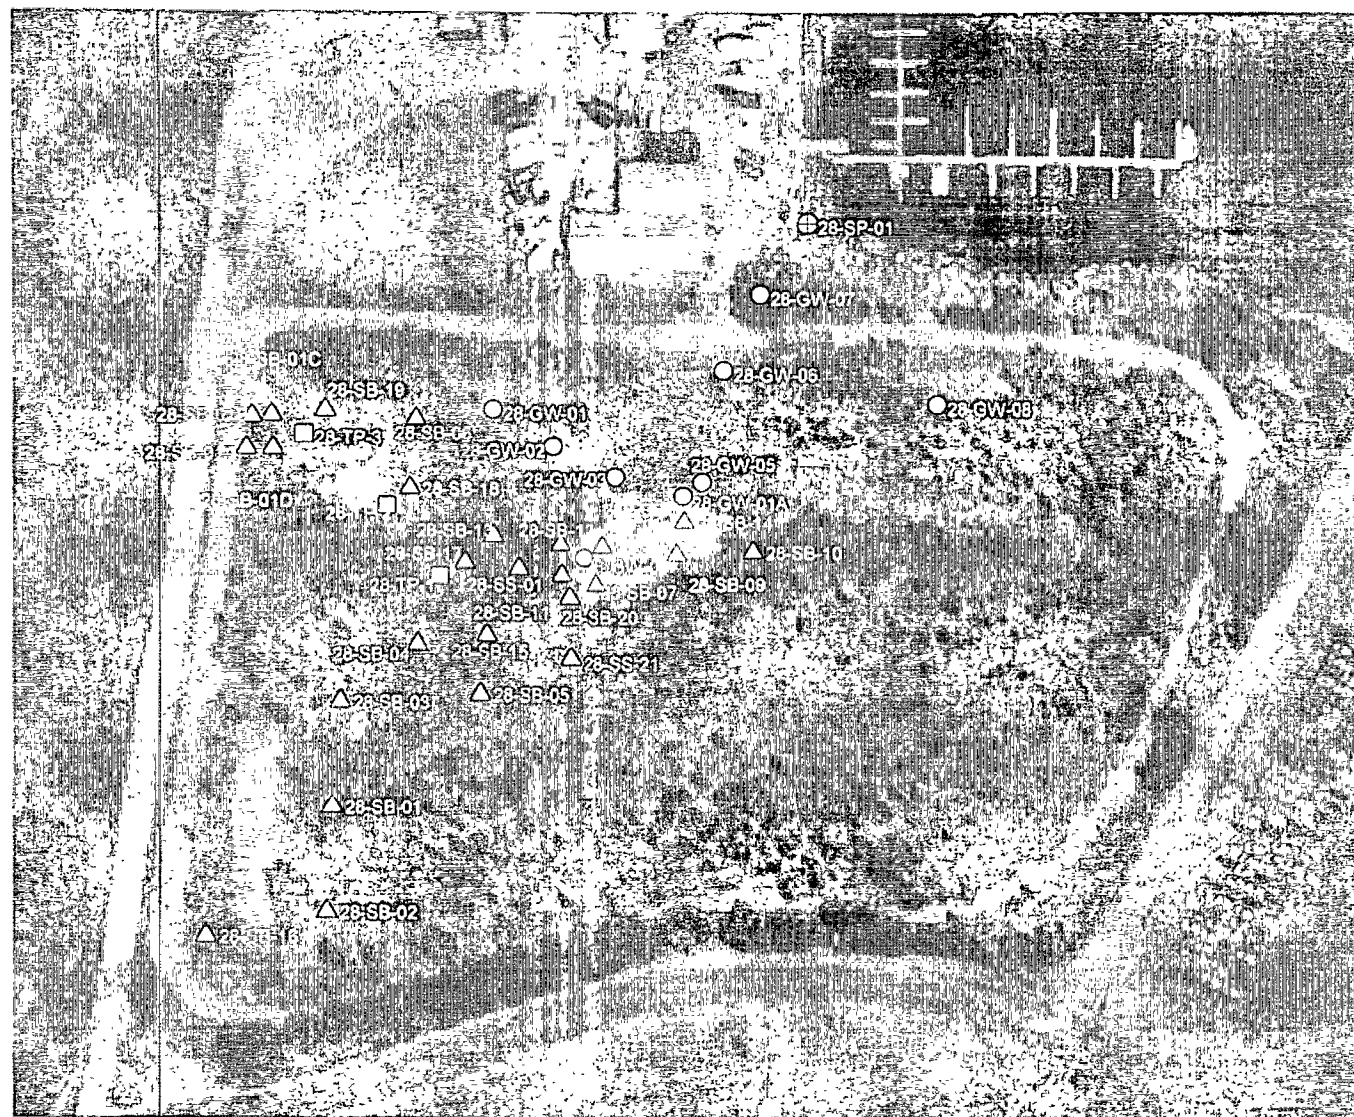
Figure 1-2
Site Map, Study Area 16

Study Area 16 is located in the eastern portion of Zone 3 at NCBC Davisville (Figure 1-1). A Site Map is presented in Figure 1-2. The Study Area is generally defined as the area surrounded by Davisville Road to the south, Westcott Road to the west, Spink Neck Road to the east, and the Building E-107 area, former pump island area, and Allen Harbor to the north. The Site boundary shown on Figure 1-2 has been selected for convenience to be related to readily findable roads.

- Creosote Dip Tank Area – Creosote dipping of wood pilings occurred during the late 1960's in the western portion of the site. The wood pilings were dipped into tanks containing creosote and staged in the area to dry before being loaded onto ships. In the early 1990's an upended creosote dip tank was identified in the western portion of the site adjacent to the paved road. The location where the tank was found is the "original" Creosote Dip Tank Area that was first addressed by Halliburton NUS in 1992 and was further investigated by EA during the Phase II EBS. However, based on additional information provided by a former Seabee after the Phase II EBS field work was completed, the Navy learned that past creosote dipping operations were likely conducted over a larger area than originally thought. That area comprised the land west of and adjacent to a wooden bermed structure that is still present at the site (Figure 1-2). The Phase II EBS Follow-On and Addendum II work

- Former Fire Fighting Training Area – The Navy informant reported that a FFTA had been located in an asphalt-paved area to the east of the former Creosote Dip Tank Area (Figure 1-2). Reportedly, structures were constructed, doused with flammable materials, set on fire, and extinguished as part of fire fighting training exercises during the late 1960’s.

A magnetometer survey was conducted in two areas where the Navy informant recalled that USTs were located. This area was to the west of, and at the southeast corner of, Building E-107 (Figure 1-2). Locations for the magnetometer readings were established in a grid pattern. One 30 ft × 90 ft grid was established to the south of Building E-107 and a second 100 ft × 120 ft grid was established around the area of the pump island west of Building E-107 (Figure 1-2). The magnetometer survey results are presented in Appendix B-2.

- Earth Ramp Structure – One ground-water sample location (28-GW-08) was selected on the downgradient side of the earthen ramp (Figure 1-2) structure southeast of Building E-107. At this location, one ground-water sample was collected from the shallow interval and one ground-water sample was collected at the 2 ft interval above refusal.

The topography at Study Area 16 has a gradual slope from the south down to sea level at the Allen Harbor shoreline. In the past, the site was extensively bulldozed, but now has a thick vegetative cover of shrubs and grasses. No freshwater wetlands are located in Study Area 16. A partially paved access road encircles the immediate area. A small paved area is located within the site as well as a wooden bermed structure and an earth ramp structure (Figure 1-2).

- Performance of a Magnetometer Survey in the vicinity of Building E-107 and the pump island area located to the west of Building E-107 to evaluate the three tanks reportedly located in the pump island area and one tank reportedly located at the southeast corner of Building E-107 (Figure 1-2).

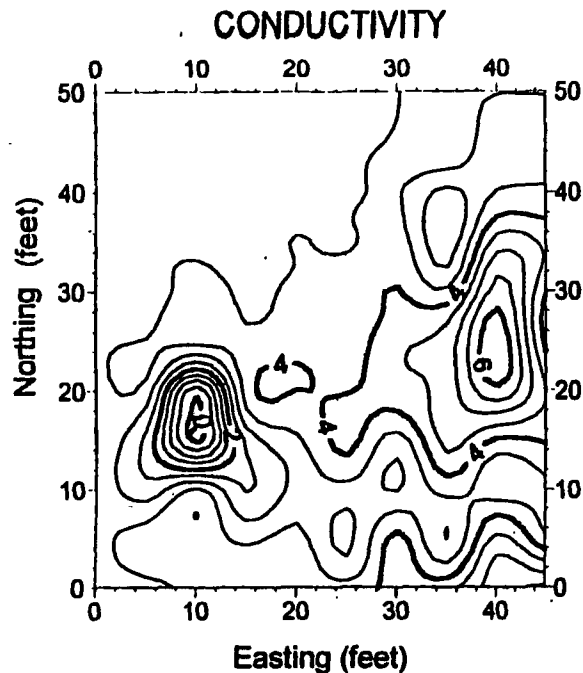
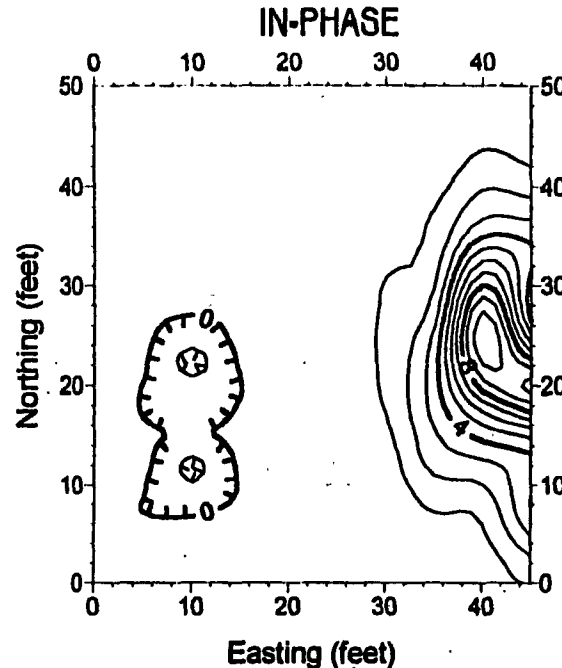
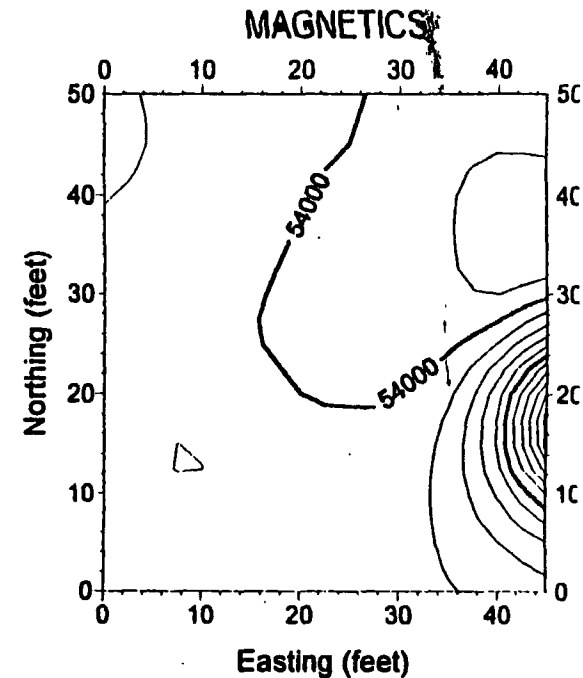
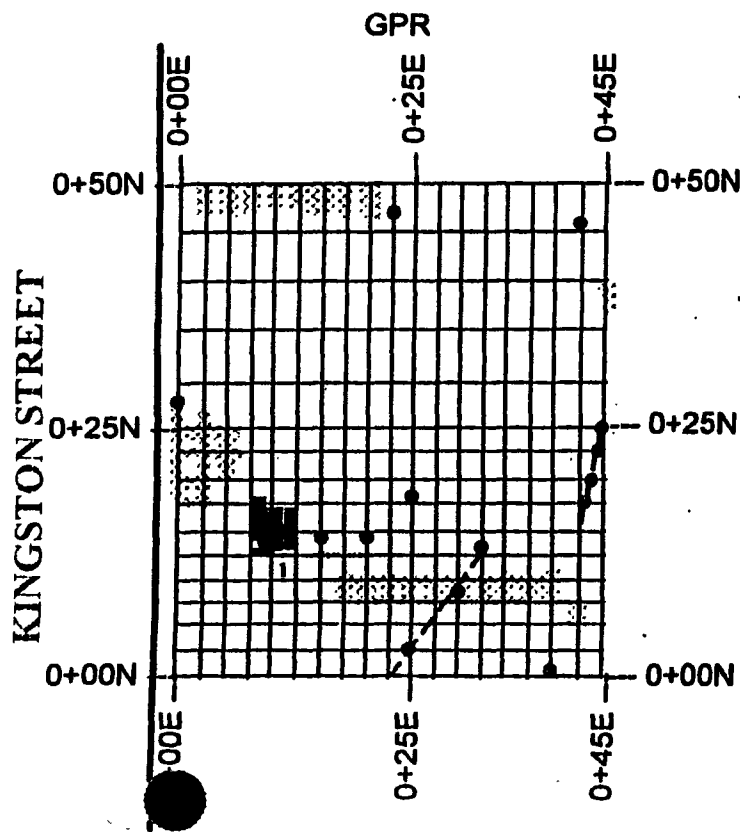
FIGURE 2
INTERPRETED GEOPHYSICAL RESULTS
SITE EBS 40
DAVISVILLE, RI
 Prepared f r
EA ENGINEERING, SCIENCE, AND TECHNOLOGY
APRIL 1996

- GPR Traverse
- GPR Point Target (metal scrap, cobble, utility)
- - - Interpreted Utility
- Possible Septic Tank and Depth
- ▨ Possible Concrete Foundation
- Interpreted Septic Tank

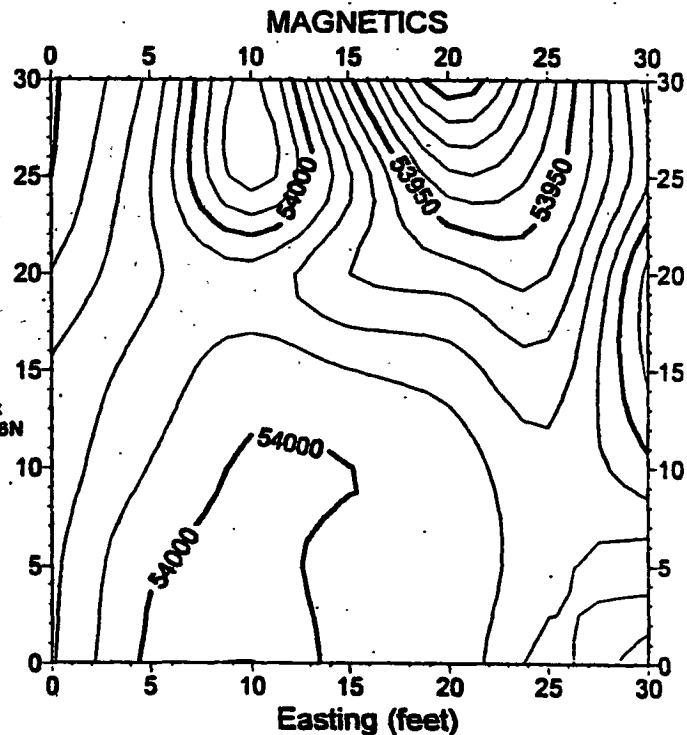
FIGURE 3
INTERPRETED GEOPHYSICAL RESULTS
SITE EBS 41A
DAVISVILLE, RHODE ISLAND
Prepared for
EA ENGINEERING, SCIENCE, AND TECHNOLOGY
APRIL 1996

NOTES: Contour intervals are as marked;
see Figure 2 for additional notes.

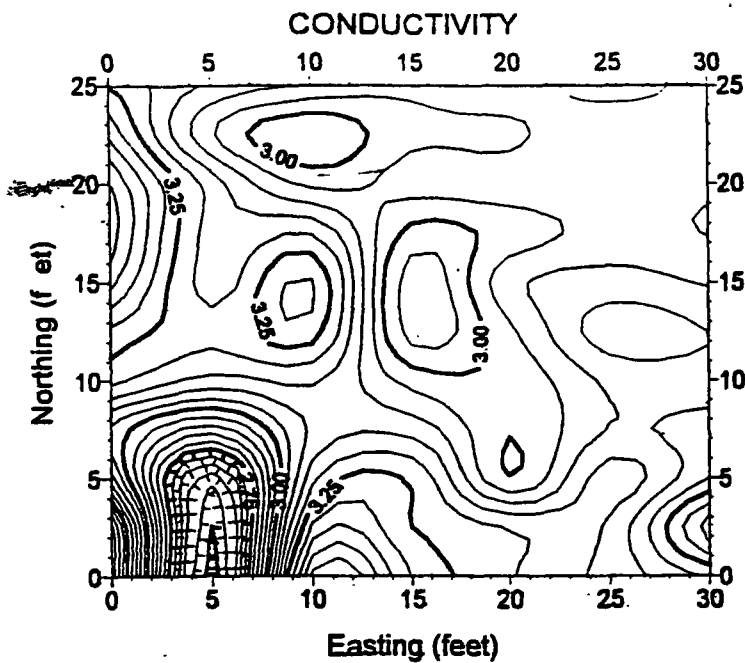
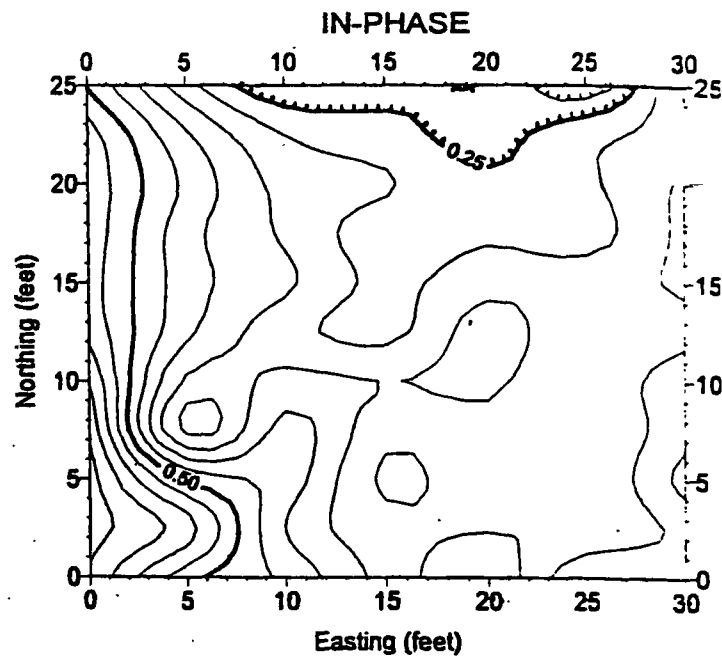
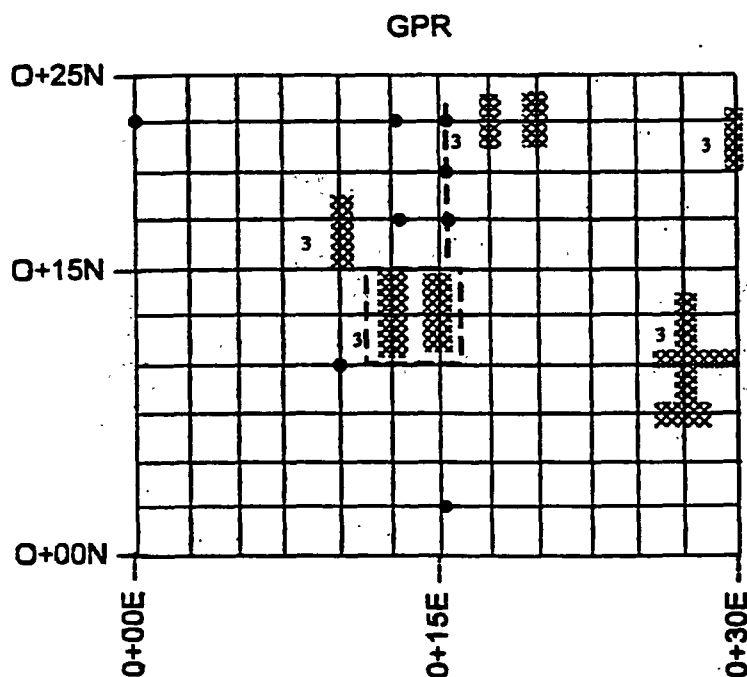
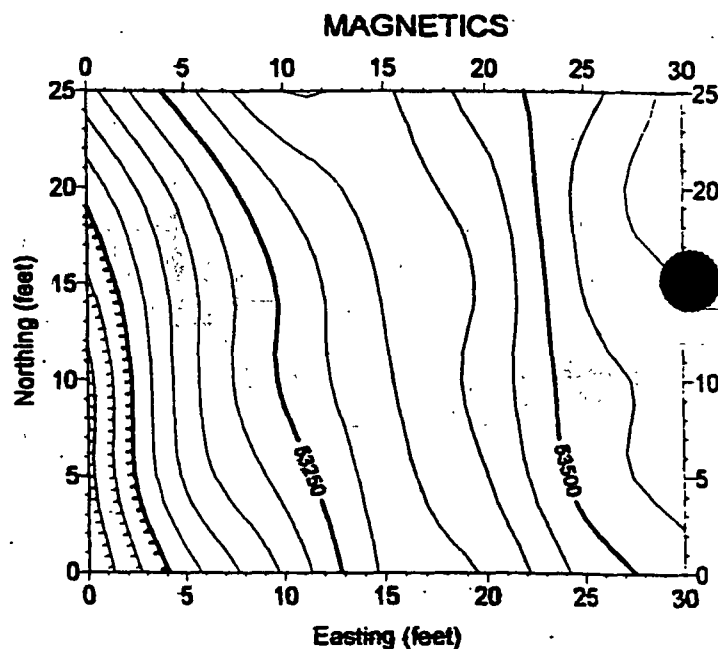
FIGURE 6
INTERPRETED GEOPHYSICAL RESULTS
SITE EBS 72
DAVISVILLE, RHODE ISLAND
Prepared for
EA ENGINEERING, SCIENCE, AND TECHNOLOGY
APRIL 1996

1) EM conductivity, in-phase, and magnetic contour intervals are as marked.

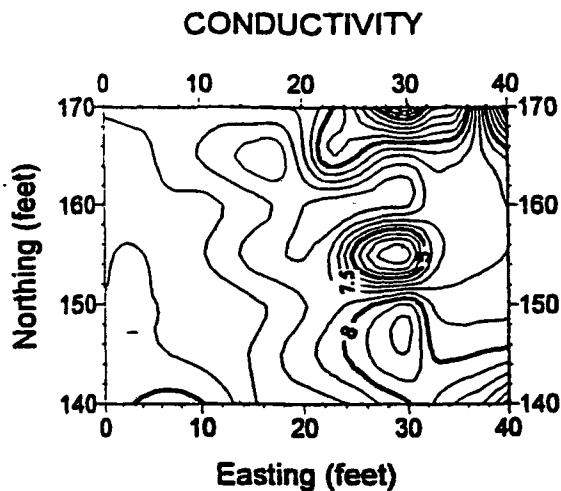
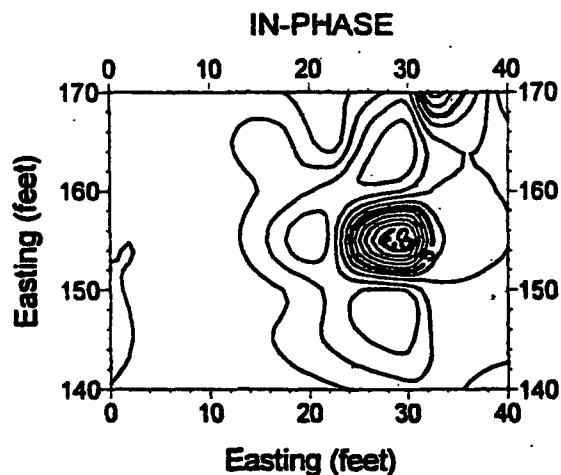
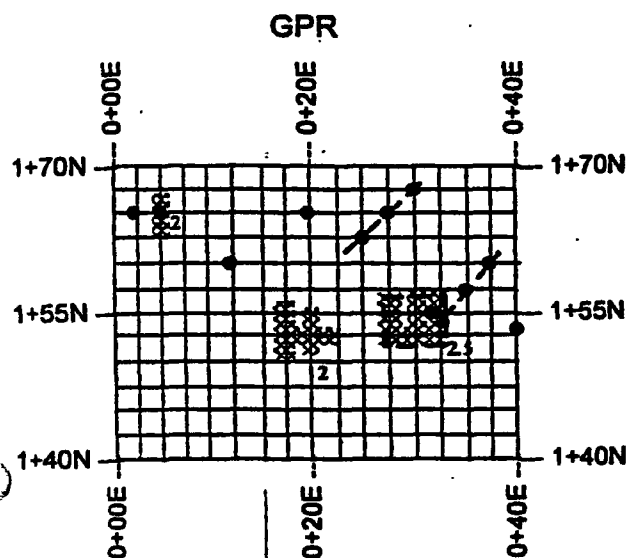
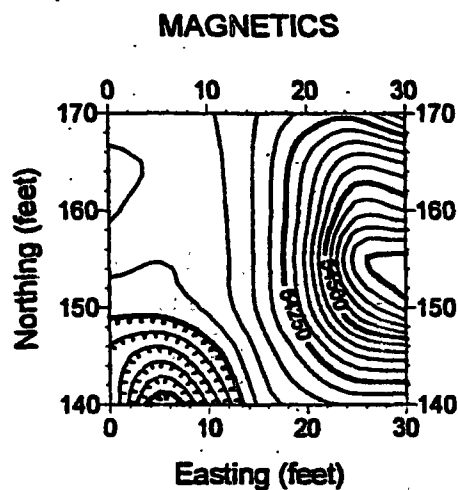
FIGURE 9
INTERPRETED GEOPHYSICAL RESULTS
SITE EBS 52
DAVISVILLE, RHODE ISLAND
 Prepared for
EA ENGINEERING, SCIENCE, AND TECHNOLOGY
APRIL 1996

- 1) Plan based on sketch from field notes.
- 2) EM31 conductivity contour interval is 0.5 millimho per meter (mmho/m).
- 3) EM31 in-phase contour interval is 1 part per thousand (ppt.)
- 4) Magnetic contour interval is 50 gammas.
- 5) Interpreted depths are based on estimated GPR propagation velocities from similar sites (see text).

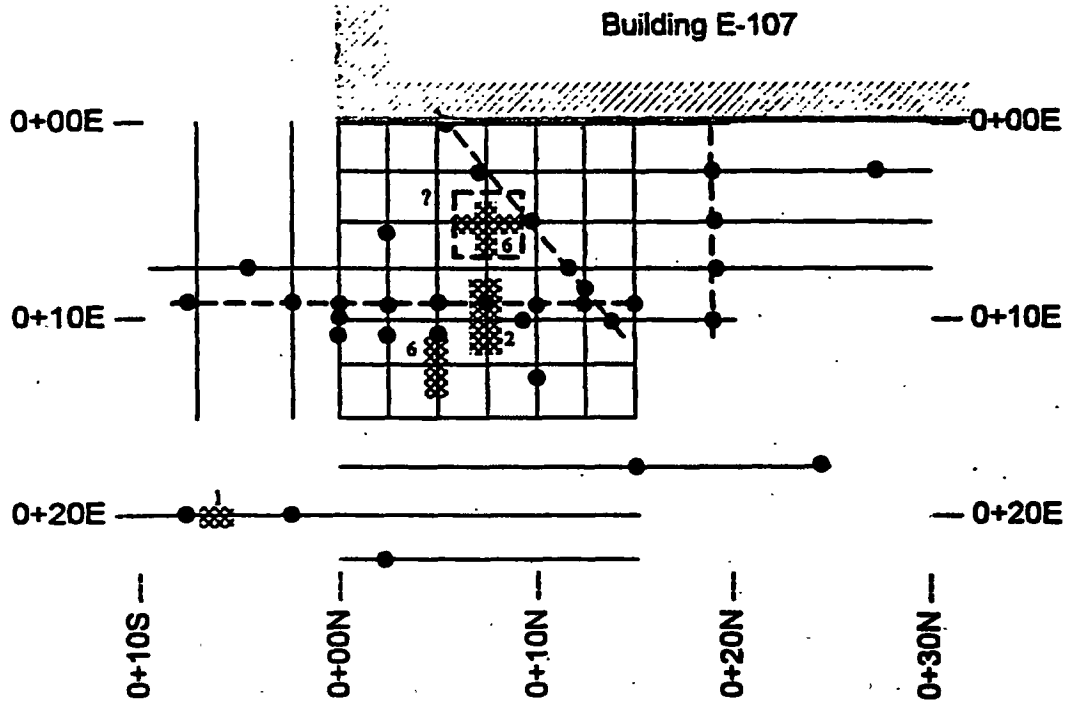
FIGURE 12
INTERPRETED GEOPHYSICAL RESULTS
SITE EBS 60
DAVISVILLE, RHODE ISLAND
 Prepared for
EA ENGINEERING, SCIENCE, AND TECHNOLOGY
APRIL 1996

- GPR Traverse
- GPR Point Target (metal scrap, cobble, utility)
- - - Interpreted Utility
- 4
Large Utility or Concrete Structure and Approx. Depth in Feet
- Interpreted Septic Tank

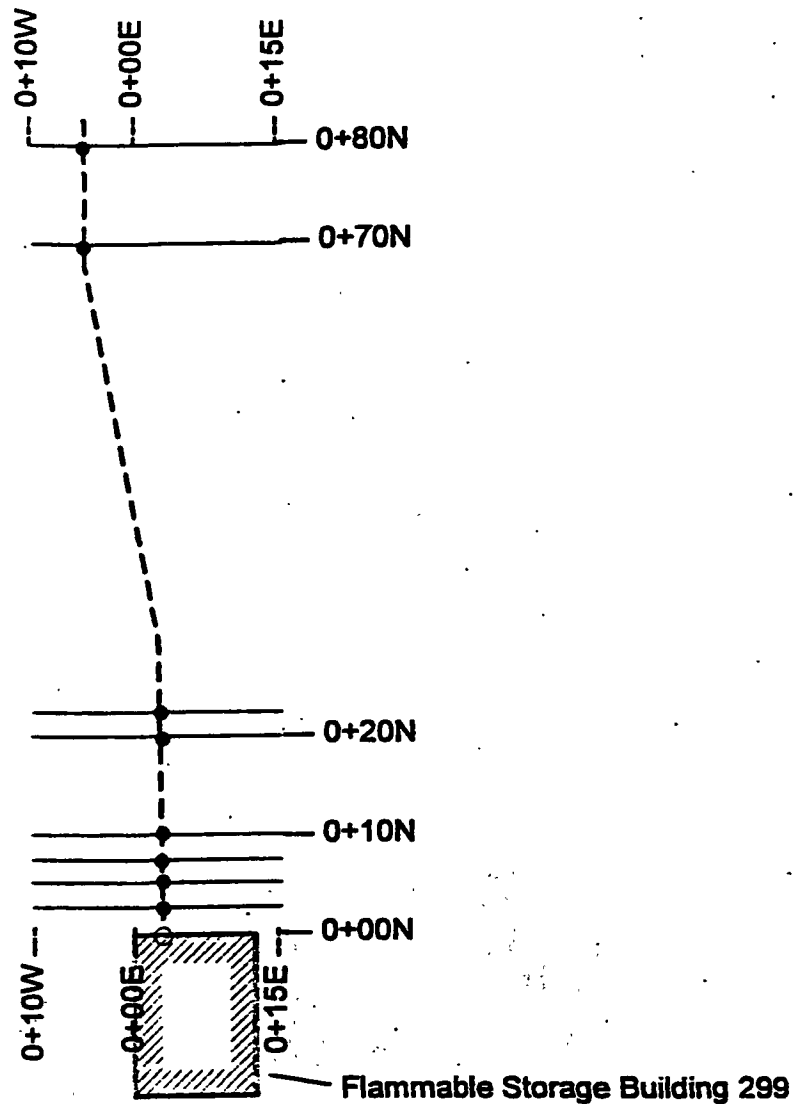
FIGURE 13
INTERPRETED GEOPHYSICAL RESULTS
SITE EBS 77
DAVISVILLE, RHODE ISLAND
 Prepared for
EA ENGINEERING, SCIENCE, AND TECHNOLOGY
APRIL 1996

- 1) Plan based on sketch from field notes.
- 2) Interpreted depths are approximate, based on estimated GPR propagation velocities from similar sites (see text).
- 3) The pipe was not detected by a GPR traverse at 1+60N, immediately beyond the catch basin.

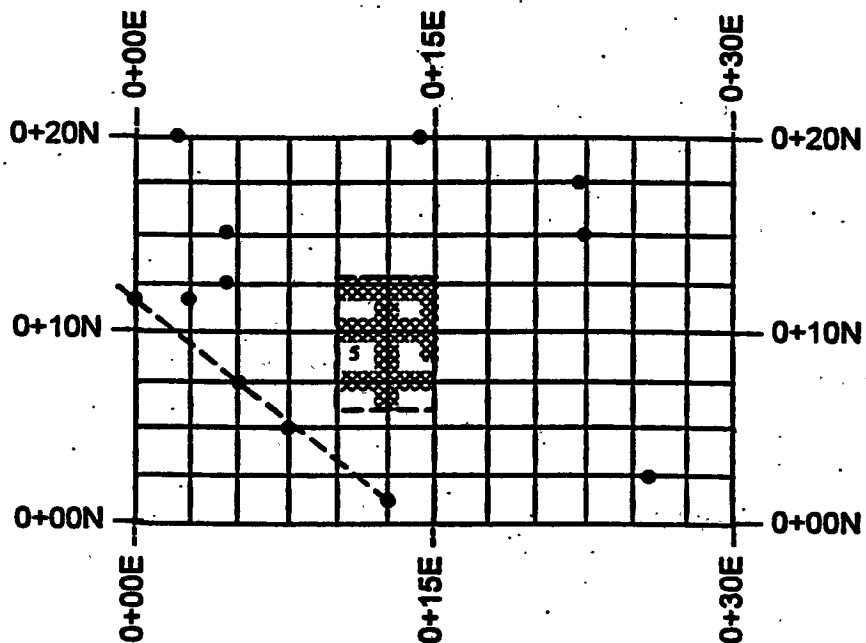
FIGURE 15
INTERPRETED GEOPHYSICAL RESULTS
SITE EBS 36
DAVISVILLE, RHODE ISLAND
 Prepared for
EA ENGINEERING, SCIENCE, AND TECHNOLOGY
APRIL 1996

- 1) Plan based on sketch from field notes.
- 2) Interpreted depths are approximate, based on estimated GPR propagation velocities from similar sites (see text).
